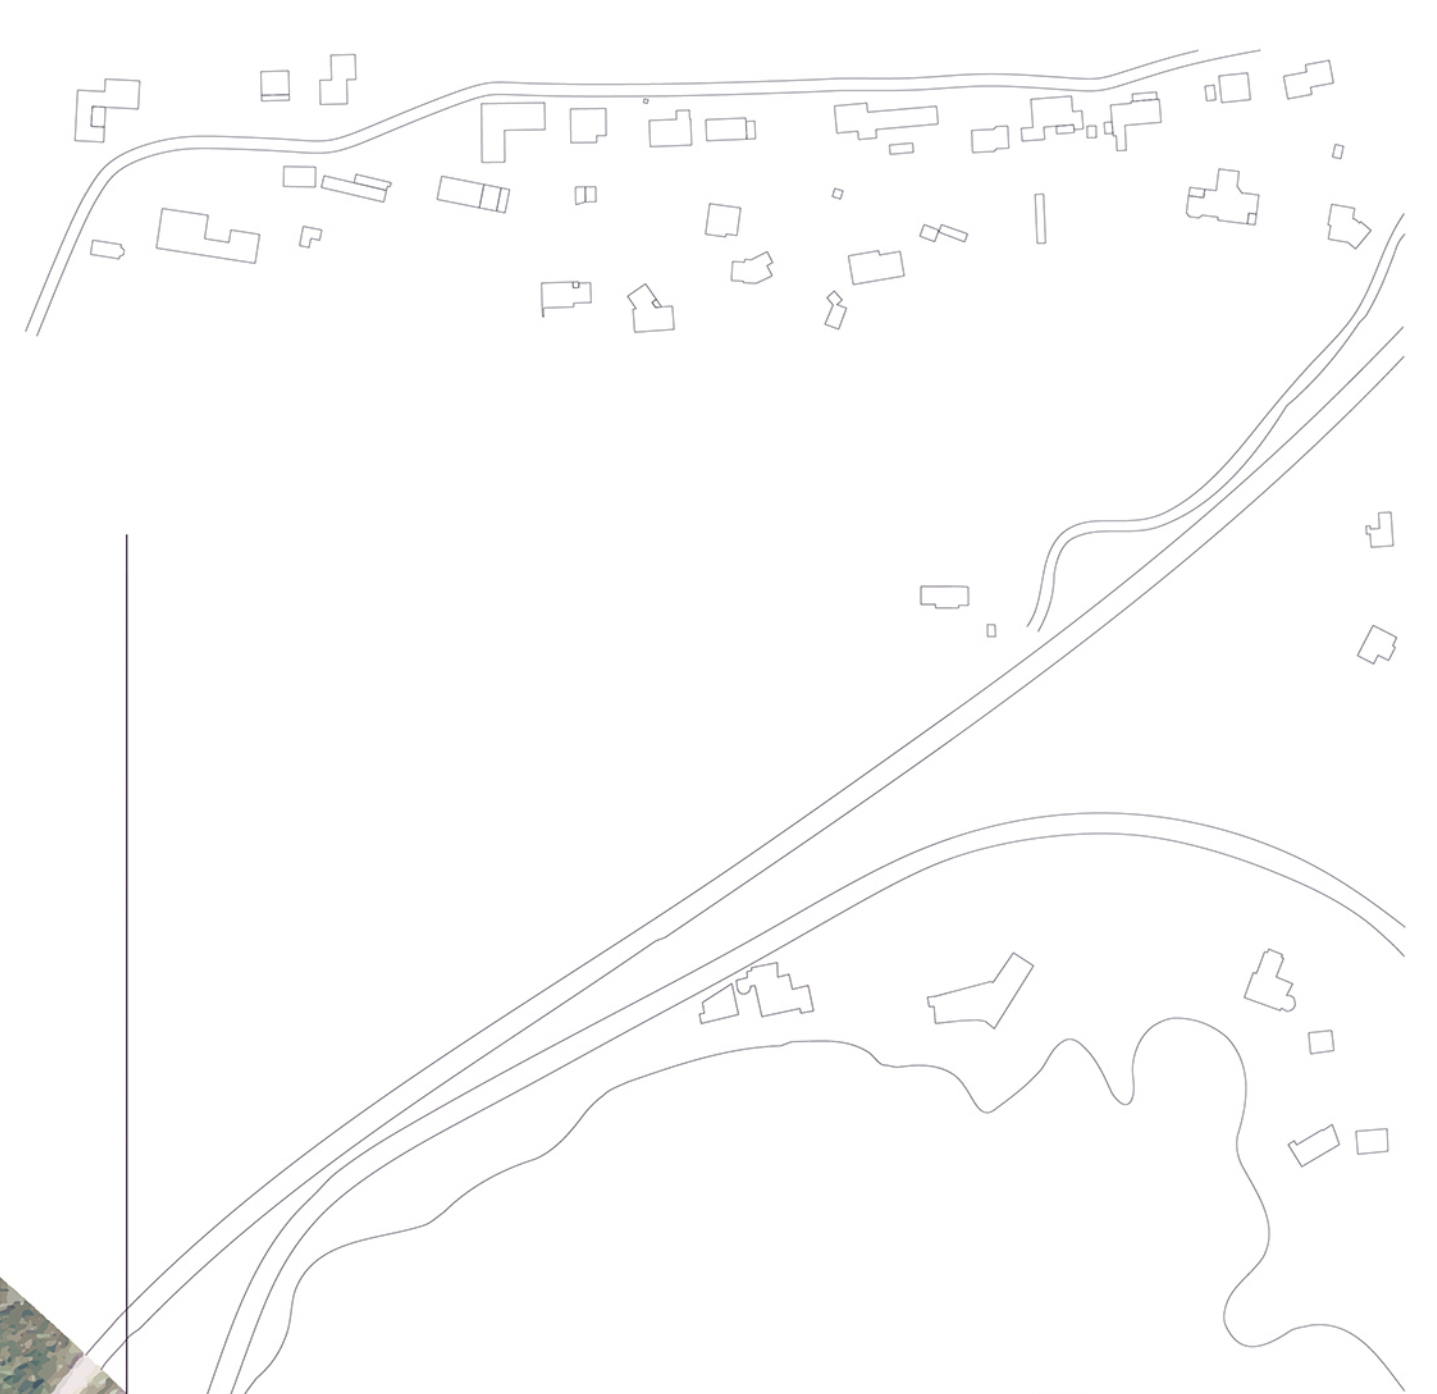
**Year 0**  
*Right after the structure was applied to the landscape*

Currently on site there is considerable erosion on the surface of the grey dune caused by trampling and worsened by wind. The ephemeral geotextile is applied to protect the sand and allow new growth to reinforce the dune.

A permanent geotextile sands where the trenches and railways of the WWII used to be, allowing the reading of currently disappearing major traces of history.

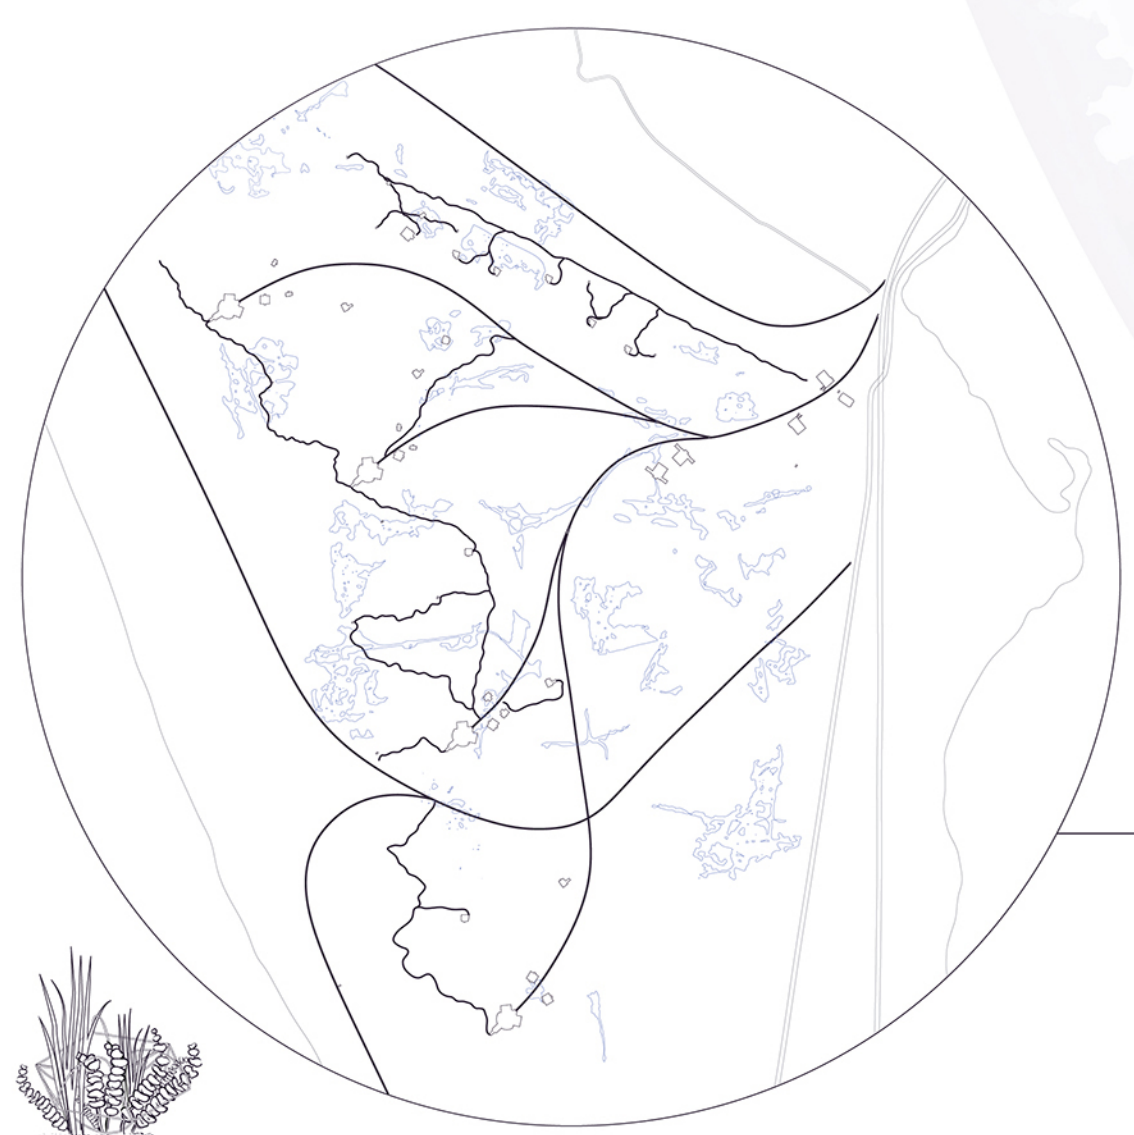
**Year 10**  
*After episodes of dry weather*

After 10 years, some extra eroded areas appeared due to the dry weather not ideal for plant growth. Some areas where the ephemeral geotextile used to be can be recognized by denser and richer vegetation.

The permanent geotextile constantly protecting the sand has fostered new plant growth and totally merged with nature. The colonization of the geotextile by the new plants makes the geotextile almost invisible. Nature and architecture become one.
